# AIRCRAFT ACCIDENT REPORT

SOUTHERN AIRWAYS, INC. DC-9, N97S

To State Airport

November 14, 1970

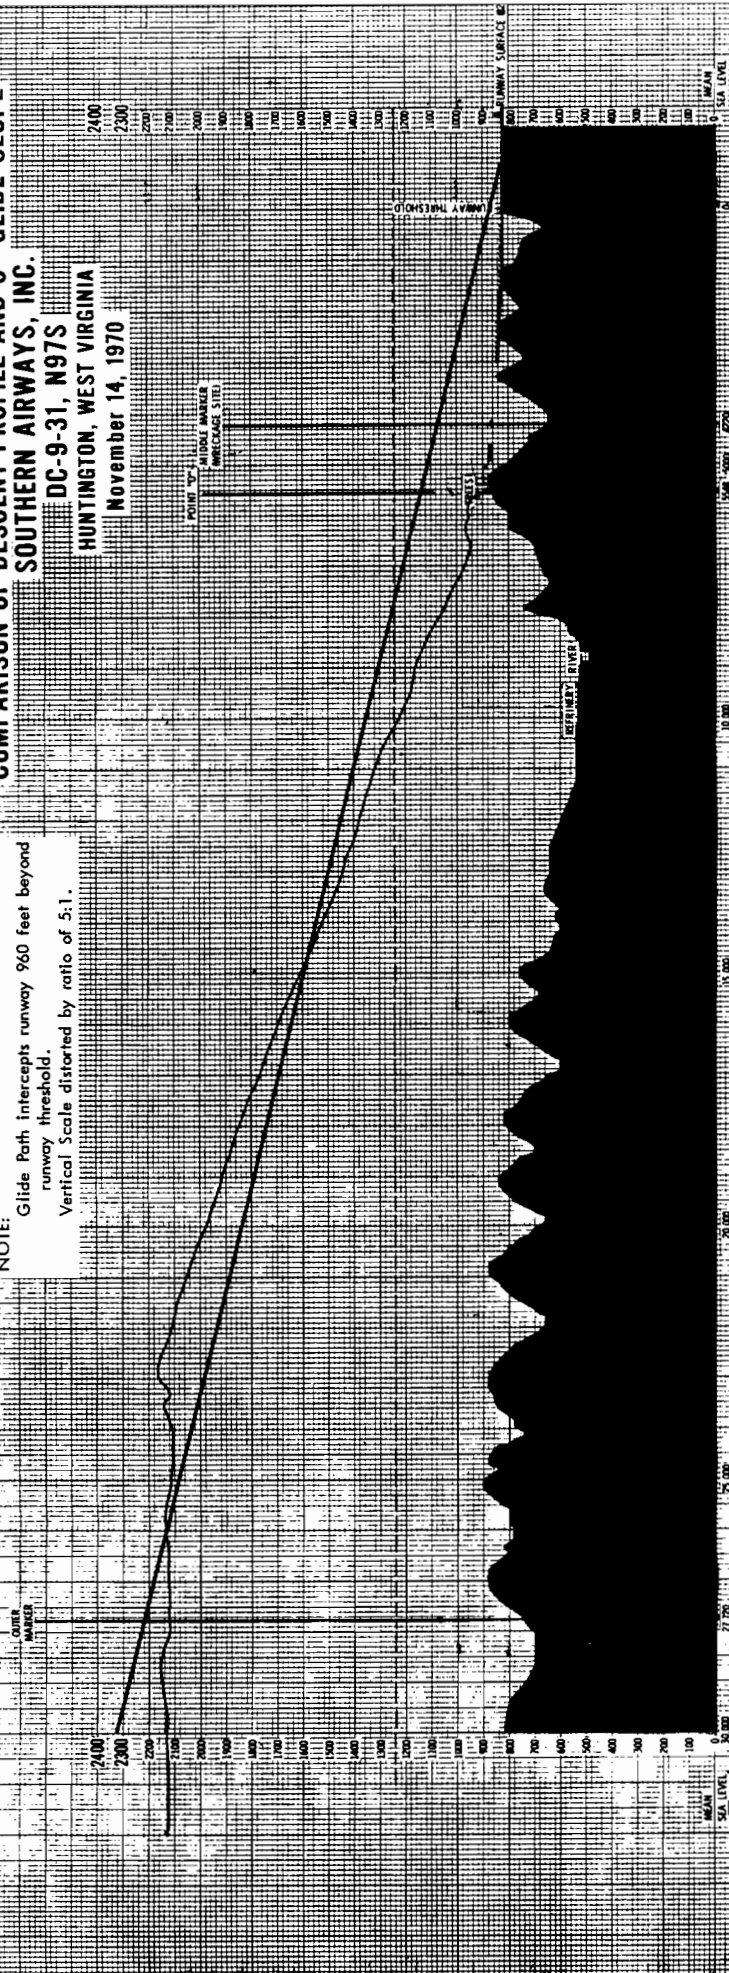
Glide Path intercepts runway 960 feet beyond runway threshold.

Vertical Scale distorted by ratio of 5:1.
