SpaceX conducts additional Falcon 9 improvements ahead of bus schedule

written by Chris Bergin | September 7, 2015

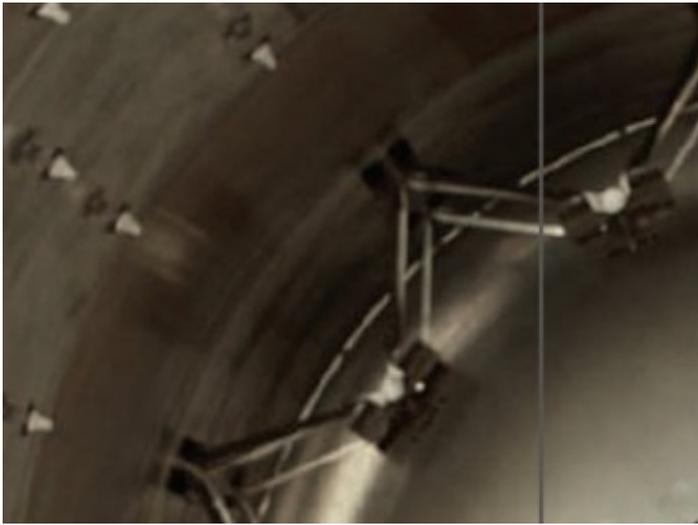
The initial focus centered on a strut, designed to hold one of the second stage helium pressurization system bottles in place. [SpaceX believes one strut "snapped" during first stage flight](#).

The failed strut is understood to have released the [Composite Overwrapped Pressure Vessel \(COPV\)](#), resulting in it leaking helium, causing an overpressure event in the tank and the subsequent failure of the stage.

However, the flight telemetry does not fully support a “straightforward failure” of a loose helium bottle bur: ^ : second stage tank.

believed this failure sequence may revolve around the bottle breaking free, twisting around, resulting in its helium line “pinching” off the helium manifold, which subsequently restores pressure in the helium system. However, it would have still released enough helium into the tank to cause the Second Stage to fail.

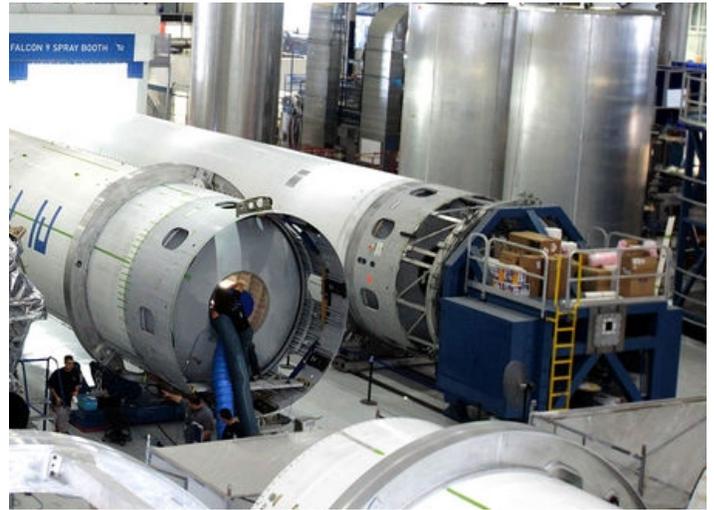
Noticed during inspections of Falcon 9 hardware at SpaceX's base in Hawthorne, California – engineers visually observed a small issue relating to weld points associated with a helium line – hardware classed as "inconel tubes" – via inspection.

Although this issue was unlikely to have impacted on the vehicle during flight, a decision was taken to change them out on the F9-19, 21 and 22 vehicles. F9-21 and F9-22 were still without their engines at the time of the decision, expediting the changeout process.
